## XIX ANIDIS Conference, Seismic Engineering in Italy

## Push ‘o ver: a pushover test program on an existing brickwork construction

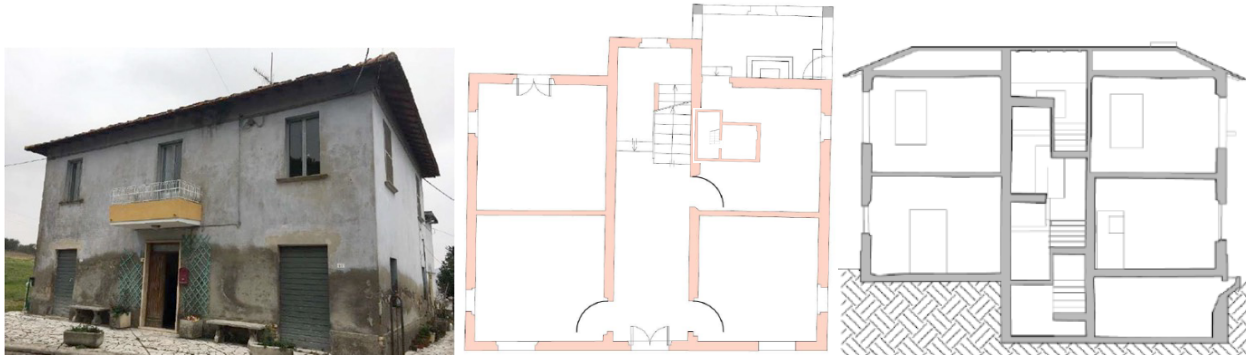
Fig. 1. The original building: view, plan and vertical section.

The original structure, built in several phases in the first half of the nineteenth century, had a rectangular plan of  $11.42 \times 10.87 \text{ m}$  (Fig. 1). A reinforced concrete small room, recently built, leaning against the main building with levels offset from it, was demolished before the start of this study. Therefore, in plan, two almost symmetrical portions joined by the central staircase were distinguishable.

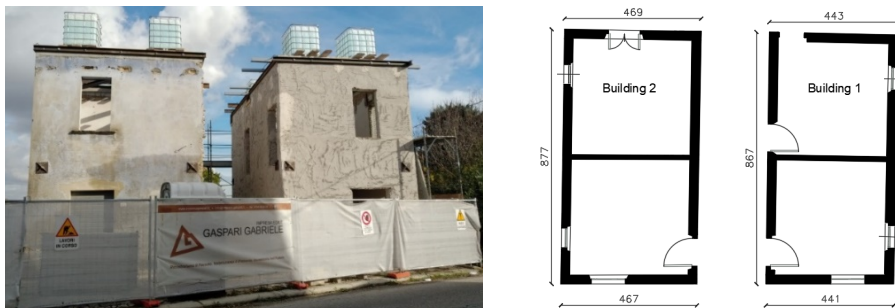
Fig. 2. Building 1 (not consolidated, on the left) and building 2. Plans of the first floors.

Due to the earthquake that affected central Italy since August 2016, the original building suffered damage in various parts. It was classified as unusable and, therefore, to be demolished and rebuilt. Taking advantage of the almost symmetry of the building, it was decided to demolish the central staircase body in a controlled manner, thus obtaining two portions that were almost equal from a structural point of view (Fig. 2). These will be referred as to building 1 and building 2 in the following.

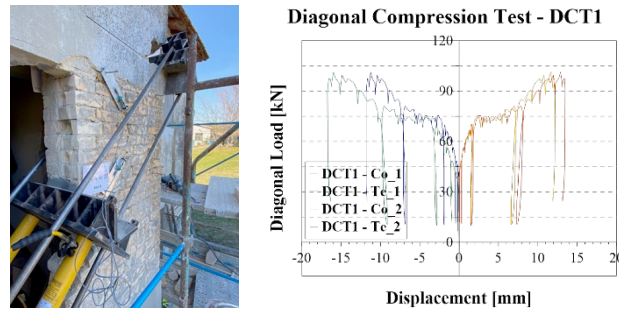
Fig. 3. Diagonal compression test setup and load – diagonal displacement diagrams.

The demolished portion of the building was used for the following in situ tests on walls: i) Tensile tests for bending and compression tests on several brick specimens; ii) Single and double flat jack tests to determination of the stress state and of the deformability and strength characteristics of the masonry; iii) Diagonal compression tests on non-reinforced masonry (Fig. 3).

The main results are summarized as follows: i) The compression tension in masonry was about  $0.29 \text{ N/mm}^2$  at the measure point; ii) The elastic modulus of masonry was  $1278 \text{ N/mm}^2$ ; iii) The tension at the first crack was  $2.0 \text{ N/mm}^2$ ; iv) Diagonal:  $f_{t,RILEM} = 0.228 \text{ N/mm}^2$ ;  $f_{v0} = 0.152 \text{ N/mm}^2$ ;  $G = 748 \text{ N/mm}^2$ ;  $E = 2135 \text{ N/mm}^2$ . These values were considered for the sizing of the test apparatus and to calibrate the Fiber Net CRM consolidation system in order not to cause excessive increases in strength and stiffness.

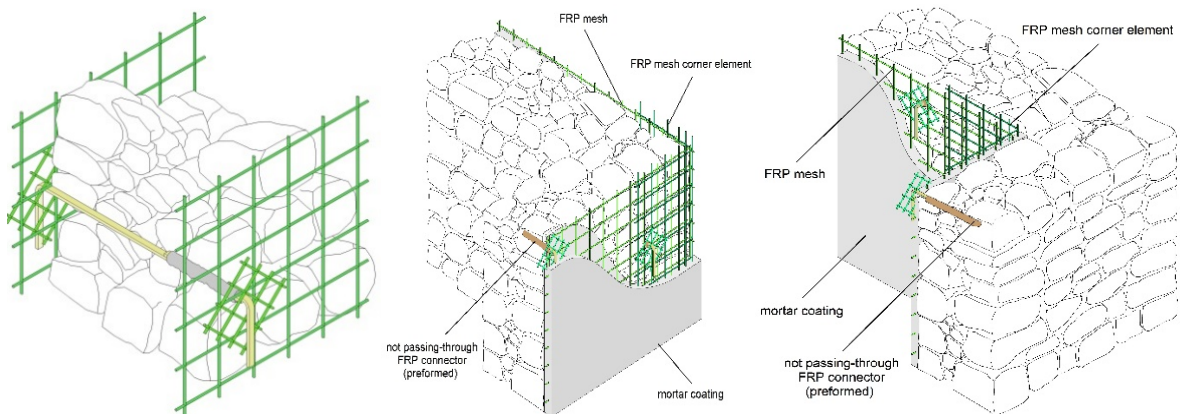
Fig. 4. Fibre Net system.

The application of the Fibre Net system consists in the following steps (Fig. 4).

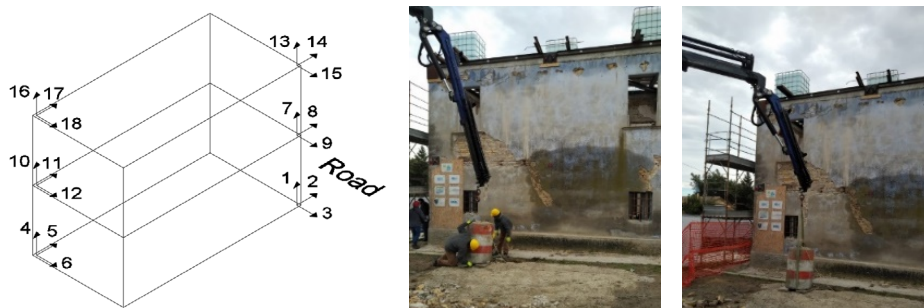
Fig. 5. Dynamic characterization: sensor deployment for each building and tests with mass drop.

The dynamic characterization tests of the two buildings were performed using six Sara SL06 three-axial velocimeters arranged at the edges of the three levels called first, second and top, respectively. In the following, the two fronts indicated in the figures will be indicated respectively with "road" and "valley" and as longitudinal the sensors parallel to the longer side and transversal those parallel to the shorter side. Fig. 5 shows the position of the sensors in the buildings. The characterization was performed using both environmental noise, which included the effects of construction site activities, and impulses caused by the fall of a concrete cylinder weighing about half a ton from varying heights, up to about 5 m, as the source of stress. Spectral analysis of the recorded signals was performed, both for environmental noise and for impulse tests, calculating the power spectra density (PSD) for all sensors and the cross spectral density (CSD) between significant couples of sensors.

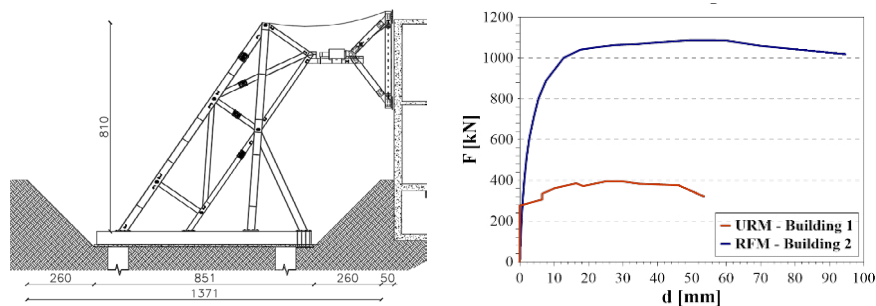
Fig. 6. Scheme of the push structure and experimental push-over diagram.

To apply the thrust to both building 1 and building 2, a suitable contrast steel truss structure was realized on purpose (Fig. 6). A prism-shaped truss structure was used to apply the forces at four points of each building, at the intersections between the longitudinal walls and the second and third floor, respectively. Two hydraulic jacks were

between the contrast structure and the prism-shaped one. The geometry was studied in order to have the upper forces double than the lower ones, simulating the first modal shape of each building.

The same system was used for both building 1 and building 2. It was fixed on a reinforced concrete plate, realized for each building and founded on four piles (length = 13 m, diameter 800 mm). The design of this structure and the foundation was performed by setting up a suitable finite element model, using SAP 2000 code, on the basis of the expected resistance of each building, suitably amplified. Pushover tests were carried out until collapse, increasing the horizontal forces at the two floors. In the tests, numerous potentiometer transducers were used to survey the displacements at several points of the specimen, to evaluate: i) floor drifts, ii) deformation in compression and in tension of the piers and the spandrels of the shear walls, iii) uplift, iv) sliding between foundations and shear walls, in the areas immediately below the points of application of the loads. During the test the graph of the applied force against the drift and the diagonal displacement of the shear walls, single piers and spandrels were monitored so to check the development of the test and to evidence the occurrence of some local damages (cracks, dislocations, etc).

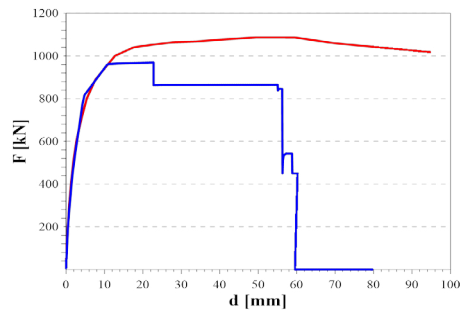
Fig. 7. Experimental (red) and numerical (blue) force-displacement response curve for building 2.

The experimental results were analyzed carefully and compared with those obtained from a suitable numerical model. This was developed adopting the force-based equivalent frame procedure already proposed to analyze the masonry wall in-plane structural response under lateral loadings (Addessi et al. 2015). The used macro-element formulation consists of the arrangement in series of a central elastic beam, two nonlinear flexural hinges at the ends and a nonlinear shear link, all characterized by a rigid-plastic response (Sangirardi et al. 2019). The model proved to be computationally efficient and suitable to interpret very well masonry experimental behavior. In Fig. 7 the force-displacement response curves obtained for building 2 are also shown. The numerical results (blue curve) are in good agreement with the experimental outcomes (red curve), giving a perfect match in the initial linear and nonlinear stage. Also, a good estimate of the limit load is numerically evaluated. The subsequent sudden drops of the numerical curves are related to the ultimate displacement values attained by some plastic hinges and correspond to the formation of severe nonlinear flexural/shear mechanisms.
