## XIX ANIDIS Conference, Seismic Engineering in Italy

## Push ‘o ver: in situ pushover tests on as built and strengthened existing brickwork constructions

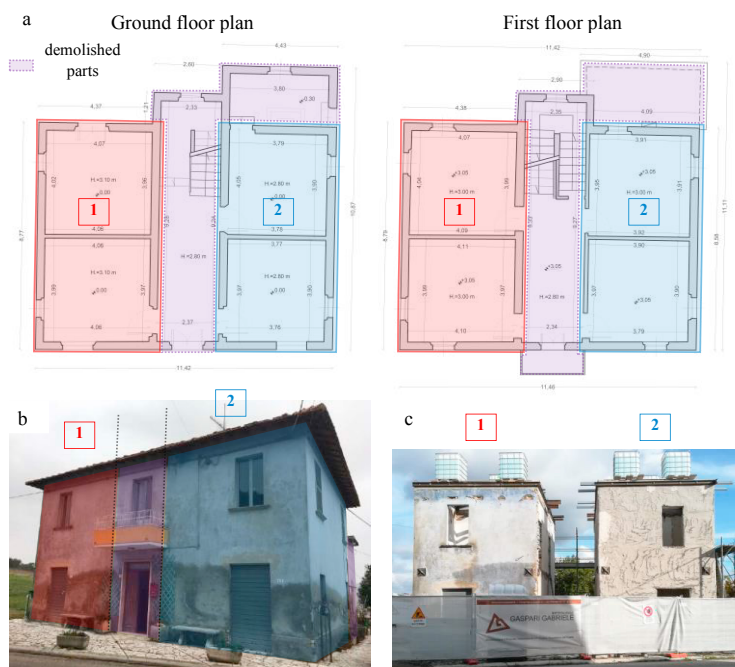
Fig. 1. (a) Ground and first floors plant of the building; (b) image of the original building; (c) derived buildings subjected to test.

The original building, used to derive the two structures investigated (Boccamazzo et al. 2022), is an area hit by the 2016 Central Italy earthquakes. It was built in the first half of the Nineteenth Century, and it was in a bad state of conservation, with diffuse cracking patterns due to the overmentioned seismic events. The building is a two-storey clay-brick masonry structure, with an almost square shape of 11.42 m x 10.87 m, and inter-storey height of 2.80 m (ground floor) and 3.00 m (first floor). Fig. 1a, shows the ground and first storey plans of the original structure, while Fig. 1b shows a picture of the main façade of the building before the interventions and the tests. The masonry structure is made with 2-headed bricks linked by a poor mortar with an overall thickness of 0.25 m. The left part of the first floor of the building is constituted by a jack arch supported by I-beams, while the right side was realized by joists with concrete reinforced precast "I" beams. The roof is built with wood elements, while the shallow foundation is masonry. The plan distributions of the walls, identify two seismic-resistant wall cells separated by a staircase that connects the ground level with the first floor. Once demolished the central staircase and the back annexe, such structural configuration allowed to divide the building into two similar portions, called building 1 and building 2, characterized by the same dimensions and resistance with respect to the horizontal forces (Fig. 1).

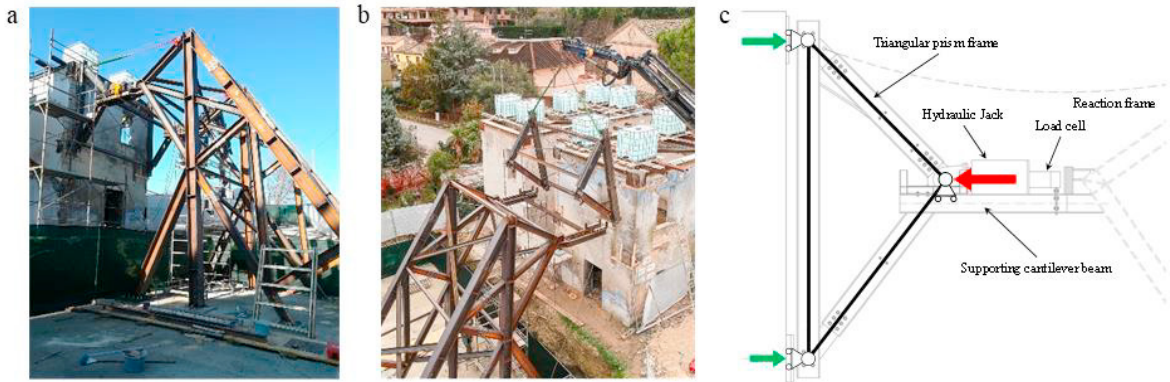
Fig. 3. (a) Pushing system during the test; (b) Assembly of the triangular steel frame; (c) Static scheme of the triangular steel frame.

cantilever beam fixed on the edge of the reaction frame supports the triangular frame (as shown in Fig. 3b,c) through a Teflon surface to minimize the friction force during the pushing phase. The ratio between the position of the contact points on the building and the height of hydraulic jacks defines the distribution of the forces applied. In this test the ratio between upper and lower forces is 1.28, to reproduce an inverse triangular pushing profile.
